MARTINDALE DAM

NDI No. PA 00444
PennDER No. 11-17

PHASE I INSPECTION REPORT NATIONAL DAM INSPECTION PROGRAM

AUGUST 1980

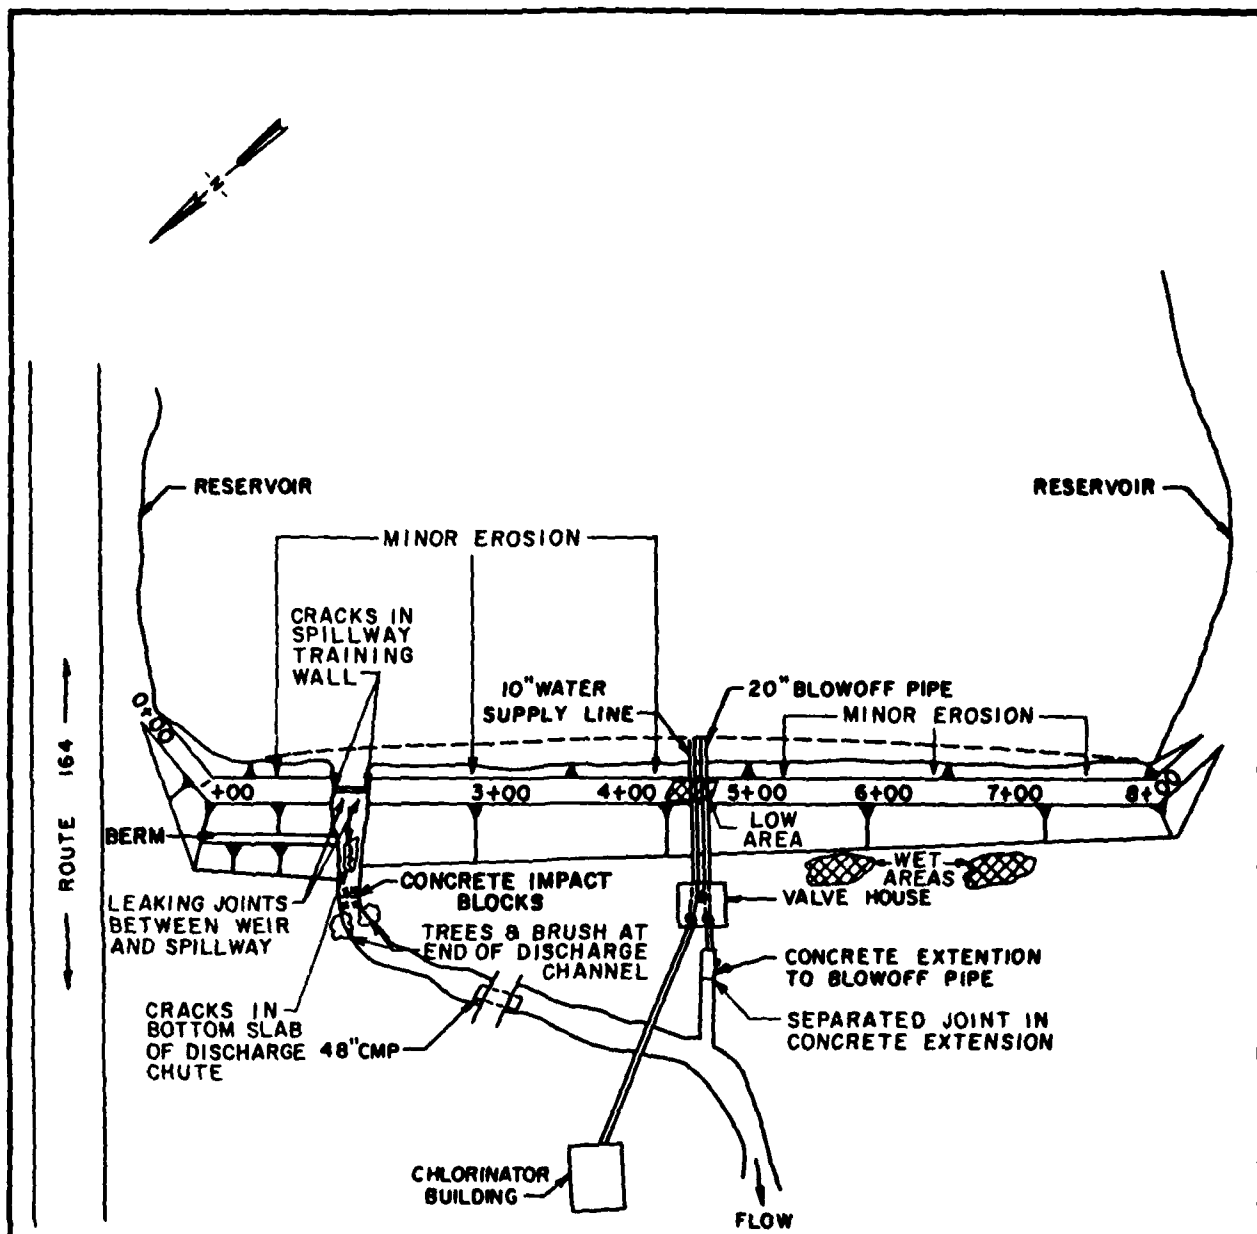
FIELD SKETCH
MARTINDALE DAM
 NDI. NO. PA 00444
 PennDER NO. 11-17
 SCHEMATIC-NOT TO SCALE

- 3) Numerous animal burrows were observed in the embankment. Many of these holes have collapsed, causing low areas on the upstream face of the dam, along the crest of the dam, and at scattered locations on the downstream face of the dam.

NOTE: ANIMAL BURROWS WERE OBSERVED ALONG THE ENTIRE EMBANKMENT.

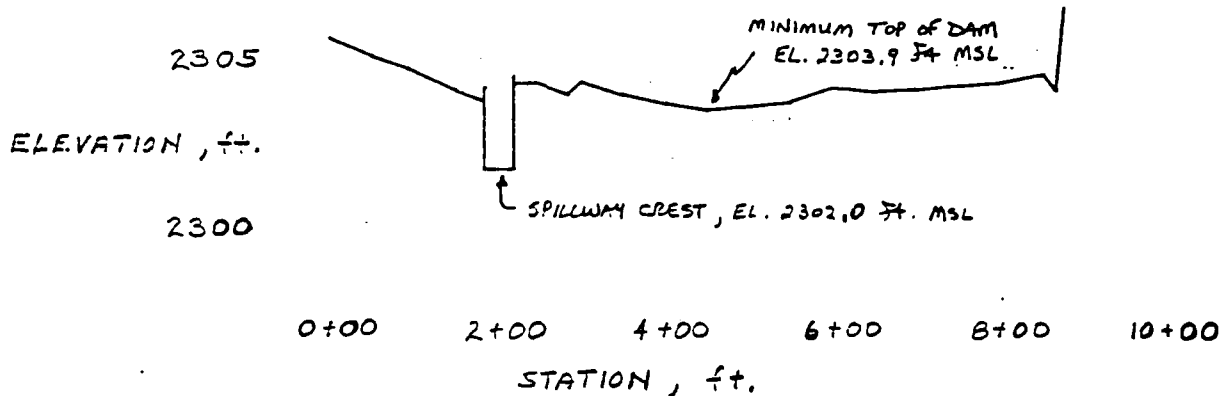
TOP OF DAM PROFILE

VISUAL EXAMINATION OF	OBSERVATIONS	REMARKS OR RECOMMENDATIONS
VERTICAL AND HORIZONTAL ALIGNMENT OF THE CREST	There is a low area at Station 4+60 on the top of dam profile included at the end of this appendix. This area is only 1.9 ft. above the crest of the spillway weir. A large portion of the crest of the dam is irregular and below the design top of dam elevation.	The low areas should be repaired.
RIPRAP FAILURES	The upstream slope is partially eroded at and above pool level.	The eroded areas should be repaired.
ANIMAL BURROWS	Numerous animal burrows were observed in the embankment. Many of these holes have collapsed to form low areas.	These animal burrows should be filled.
